Catalina 320 stemhead fitting sudden failure. Check your rig!

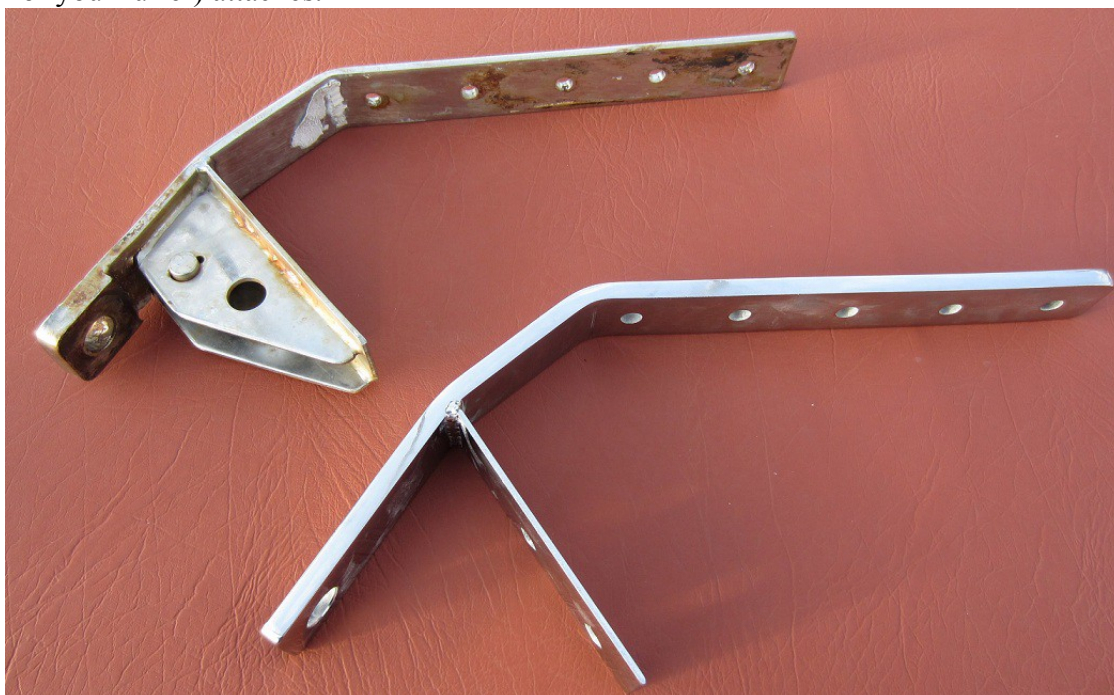
This first picture shows side by side the original design (and a replacement without the side 'gusset plates'). The left end is the part that projects upwards towards the mast and to which the forestay, or bottom of your furler) attaches.

You can see that the gusset plates are welded in place to the main steel tang. Also the top (left) of the tang is doubled in thickness and I believe this is achieved by welding the second 'square' of metal onto the main tang, grinding smooth and then drilling the hole for the forestay attachment.

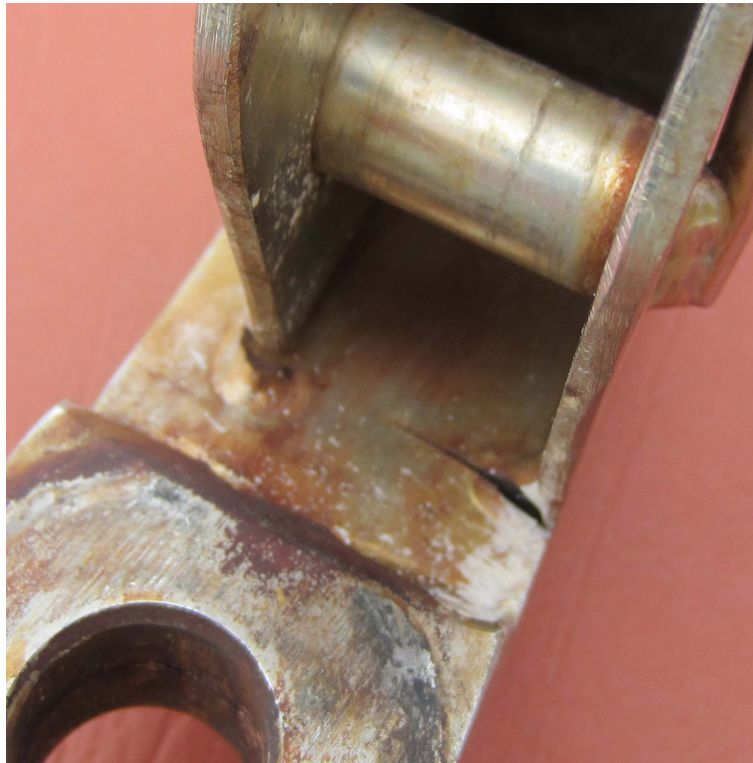
The following photo shows a crack discovered by the owner of a Catalina 36 that has the same stemhead design as the C320. Notice also on the left hand side the original weld has made an undercut that will allow crevice corrosion to begin. The weld on the right hand side has been ground flush to allow inspection.

The problem is that this area is really difficult to inspect as it is underneath the furler drum and shaded. I recommend a flashlight and maybe even a small dental mirror to really look carefully.

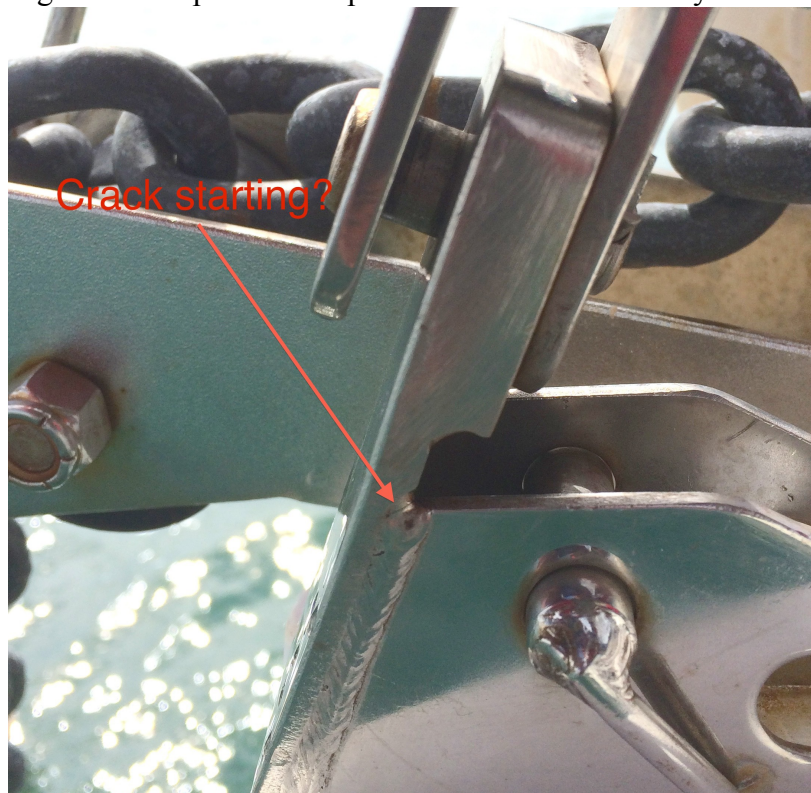
The next photo is of my own boat which I shows a hairline crack originating from the top of the weld. I will be getting further inspections/repairs carried out immediately.

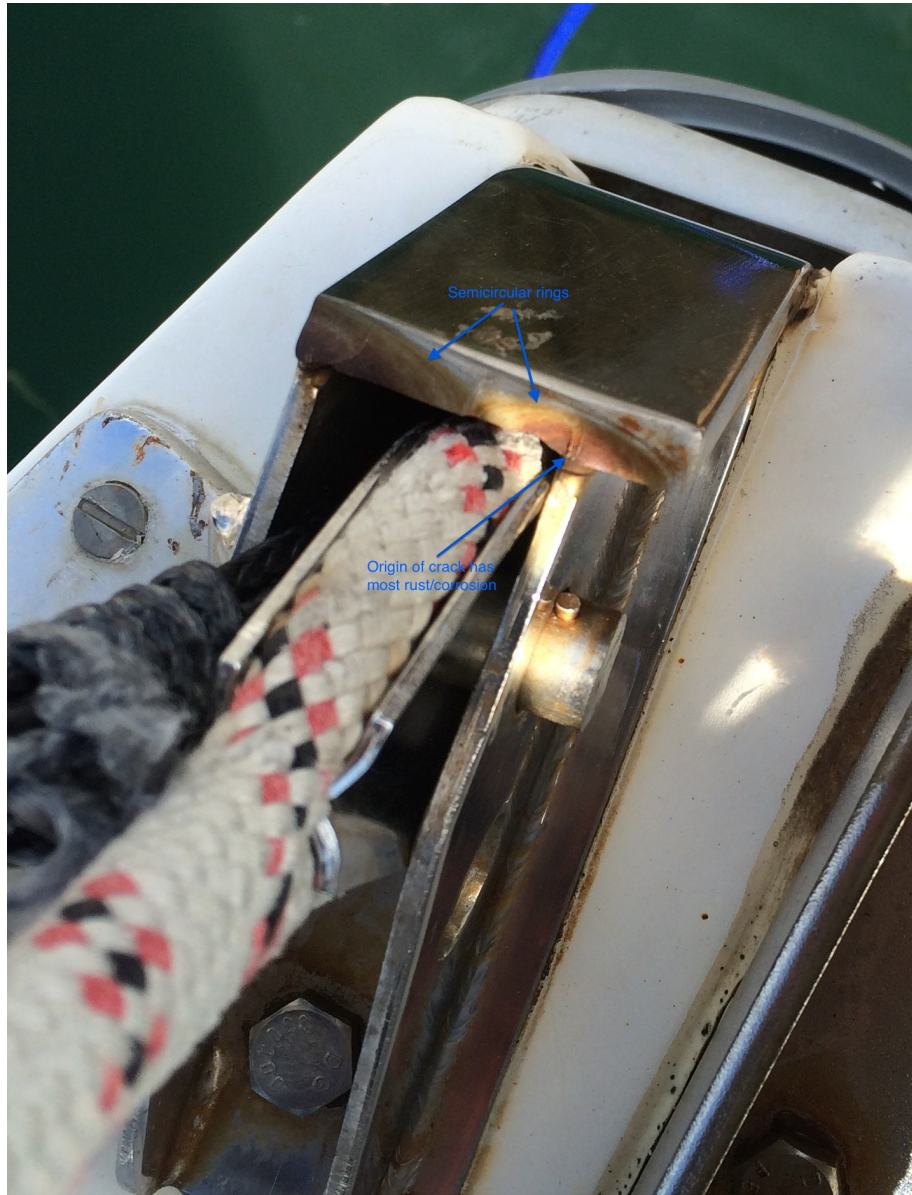
The final photo shows the same part (from a friend's C320) after it fractured whilst they were at sea in only moderate winds. They were fortunate not to lose the mast! This photo clearly shows the progression of the crack over time, demonstrated by the series of circular lines like waves on a shoreline. The older parts - nearest the weld where the crack started, are the most rusty having being exposed to corrosion for longer. The crack emanated from both sides and the T-shaped non-rusty part in the middle was the final failure under load, when it gave way. The small vertical 'nick's or 'notches' visible at the right hand side are also classic signs of fatigue progression.

In my opinion the design of this plate lends itself to this type of failure because of the welding and difficulty in inspection. It is worth noting that Catalina Direct (with whom I have no commercial or other connection) offer a replacement that does not have the side plates, but a central lug instead.

- 1) Inspect your rig carefully and regularly
- 2) Flush with fresh water as often as you can after sailing in saltwater (this will slow down but not completely prevent crevice corrosion)
