Changing the Push Button Engine Start to a Key Start

On "Watermark" Catalina 320 Hull #774

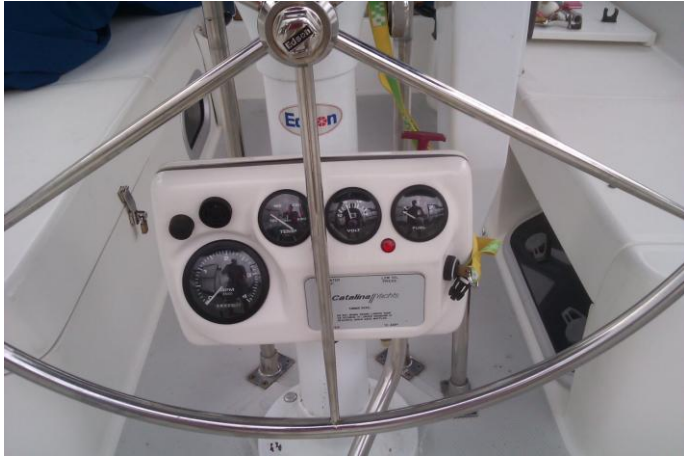
There are a few different models of engine instrument pods. This is the one on `Watermark` (2000 model)

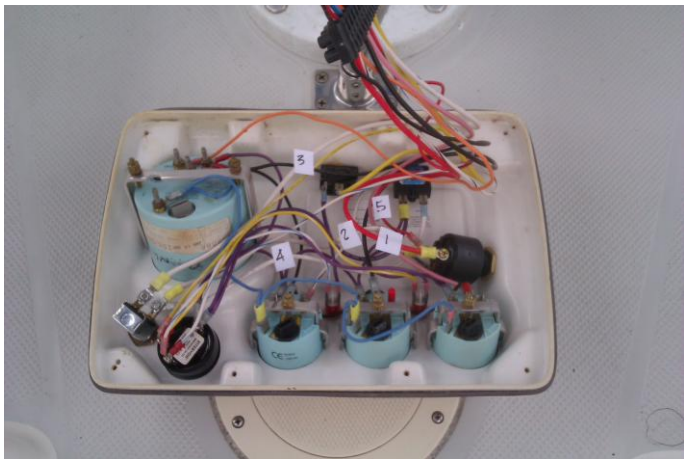
This is the original wiring set-up.

The wires I changed are numbered 1-5

- 1.Red Power to switch
- 2.White Switch Ign to push button
- 3.White Push Button to Starter
- 4.White 10Amp fuse to Push Button
- 5.Red/Black stripe Alternator exciter

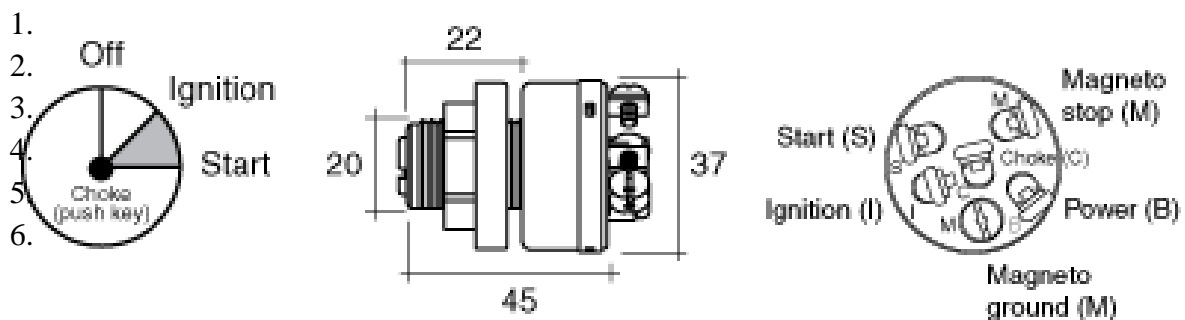
The reason all this took place was that the push button starter stuck in. This caused the solenoid to keep the starter gear engaged with the flywheel. The flywheel was rotating at about 6-800 rpm, so I don't know what rate the starter was going round but sufficient to cause the starter to burn out very quickly. (The cost for the new starter motor was \$A700)

This is the final setup.

1.The red power wire goes to the `B` terminal (pretty obvious really)

2.The white wire is taken off and not re-used.

3.The white starter wire goes to the starter `S` terminal

4.The 10 Amp fuse wire goes to the `I` ignition terminal

5.The red/black ammeter exciter wire also goes to the `I` terminal. That wire number 5 is a bit hard to see on this photo but it's the one partially hidden by wire number 1. The black stripe is easy to see just below the number 4 label
