## Servicing the Maxwell VC 500 Windlass

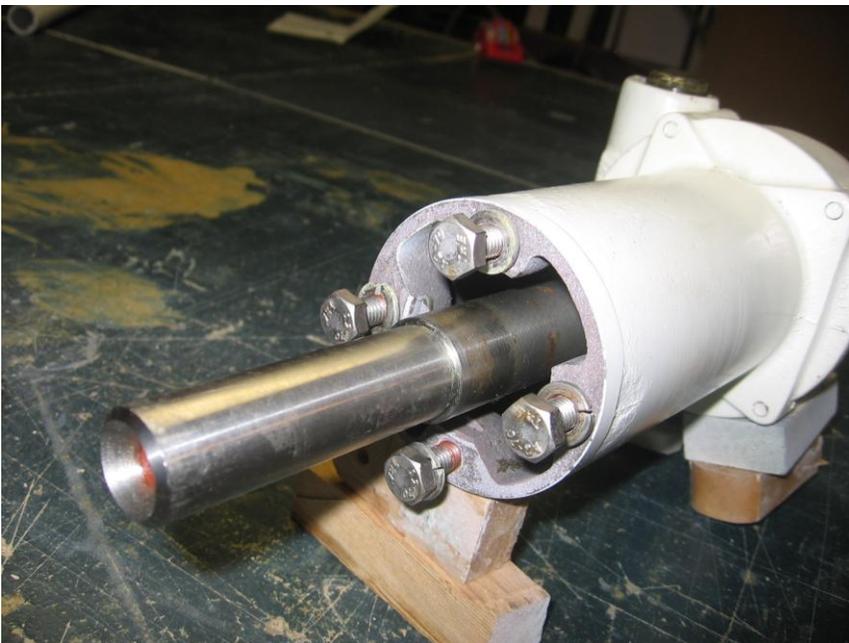
Removing the windlass itself was a breeze. To remove the unit, first use a knife or thin blade screwdriver to pop the plastic cap on the end of the drum. Then unscrew the machine screw in the center under the cap. The drum should pull right off (don't lose the shaft key). If it hasn't been removed in years, the grease may be dried and you will have to use a puller to get it off. Once the drum is off, you'll find 4 bolts underneath. Remove those

four bolts, and the unit can be removed from the V-berth. Note that the mounting ring is held in-place by 4 more bolts accessed only from inside. These do not need to be removed. After the four mounting bolts are removed inside the anchor locker, from the V-berth you can slide the unit towards starboard and drop it towards you. It's really quite easy.

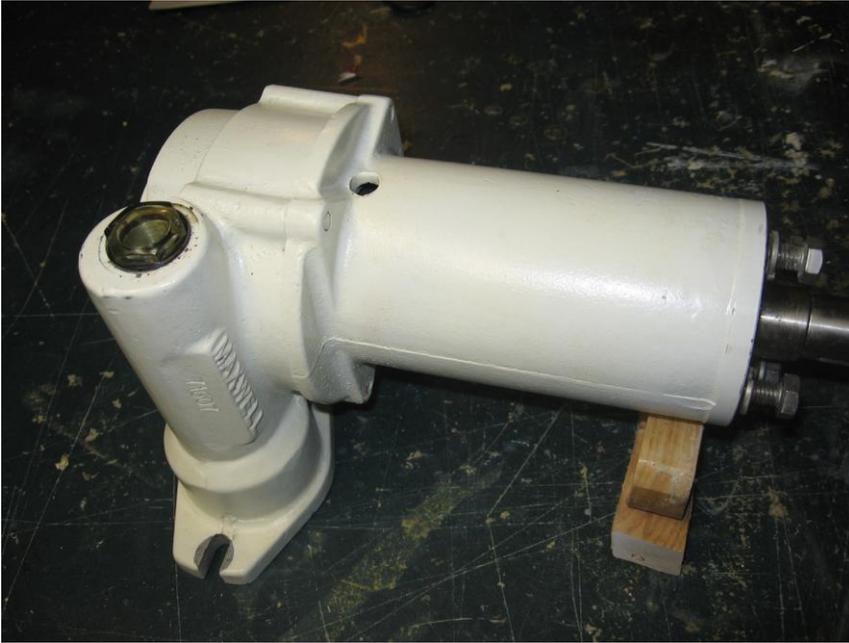
To change the oil, leave the unit in a warm (room temp) place so the oil will flow. The oil is removed by unscrewing the plastic sight cap that is screwed on. I removed about 3oz

of old oil, and replaced with 4.5oz of 80W90 gear oil. This may be more oil than recommended (ie. halfway up the sight glass) but that is for a vertical installation. Because the C320 MkI installations are horizontal, the extra oil will insure that the top bearing race is partially immersed. Note that the Maxwell manual recommends an extreme pressure, SAE 90 gear oil, and suggests two brands of ISO 320 oil. These may be difficult to find. In researching viscosities, I think 80W90 gear oil (such as lower unit oil) is an acceptable compromise if you cannot find straight 90 weight or the ISO 320 oils. It will actually flow better at low temperatures and still has

adequate extreme pressure additives. Most of us do not put enough time on the windlass to be concerned about additive breakdown.
